**INDIAN CREEK MINE DAMS  
WASHINGTON COUNTY, MISSOURI  
MO 30717 & 31036**

**PHASE 1 INSPECTION REPORT  
NATIONAL DAM SAFETY PROGRAM**

**FEBRUARY 1980**

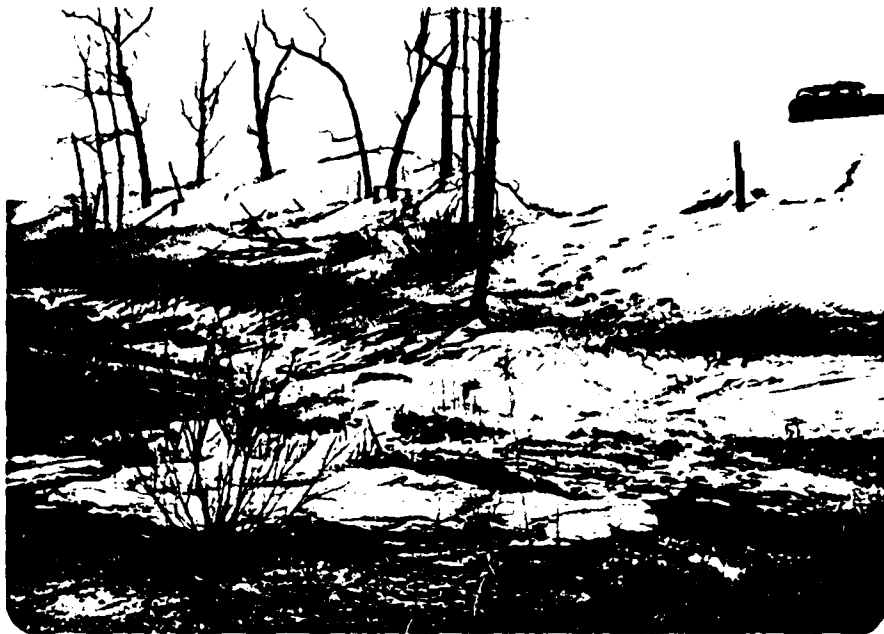
<u>Photo No.</u>	<u>Description</u>
1	Toe of tailings embankment near right abutment. Note seepage near toe and bedrock exposure.
2	View of dam toe along rock buttress at maximum section. Note erosion.
3	Toe of dam at maximum section. Note erosion and marshy ground.
4	View downstream from crest toward area behind left abutment. Note seepage wetting line, abandoned spigot line supports, and erosion rills at edge of the old dam.
5	Diverted drainage ponded behind left abutment. Note seepage through diversion dike.
6	Typical sloughing of embankment tailings from seepage.
7	Area below toe of starter dam. Note eroded materials and marshy ground.
8	View toward right abutment showing downstream slope and toe of starter dam. Note rock buttress, eroded materials and marshy ground at toe.
9	Spillway channel downstream from bridge. Note condition of slopes and materials.
10	Entrance to spillway channel.
